NASA Technical Memorandum 86347

**DIRECT-STRIKE LIGHTNING PHOTOGRAPHS,
SWEPT-FLASH ATTACHMENT PATTERNS,
AND FLIGHT CONDITIONS FOR
STORM HAZARDS '82**

**Klaus P. Zaepfel,
Bruce D. Fisher,
and Merle S. Ott**

February 1985

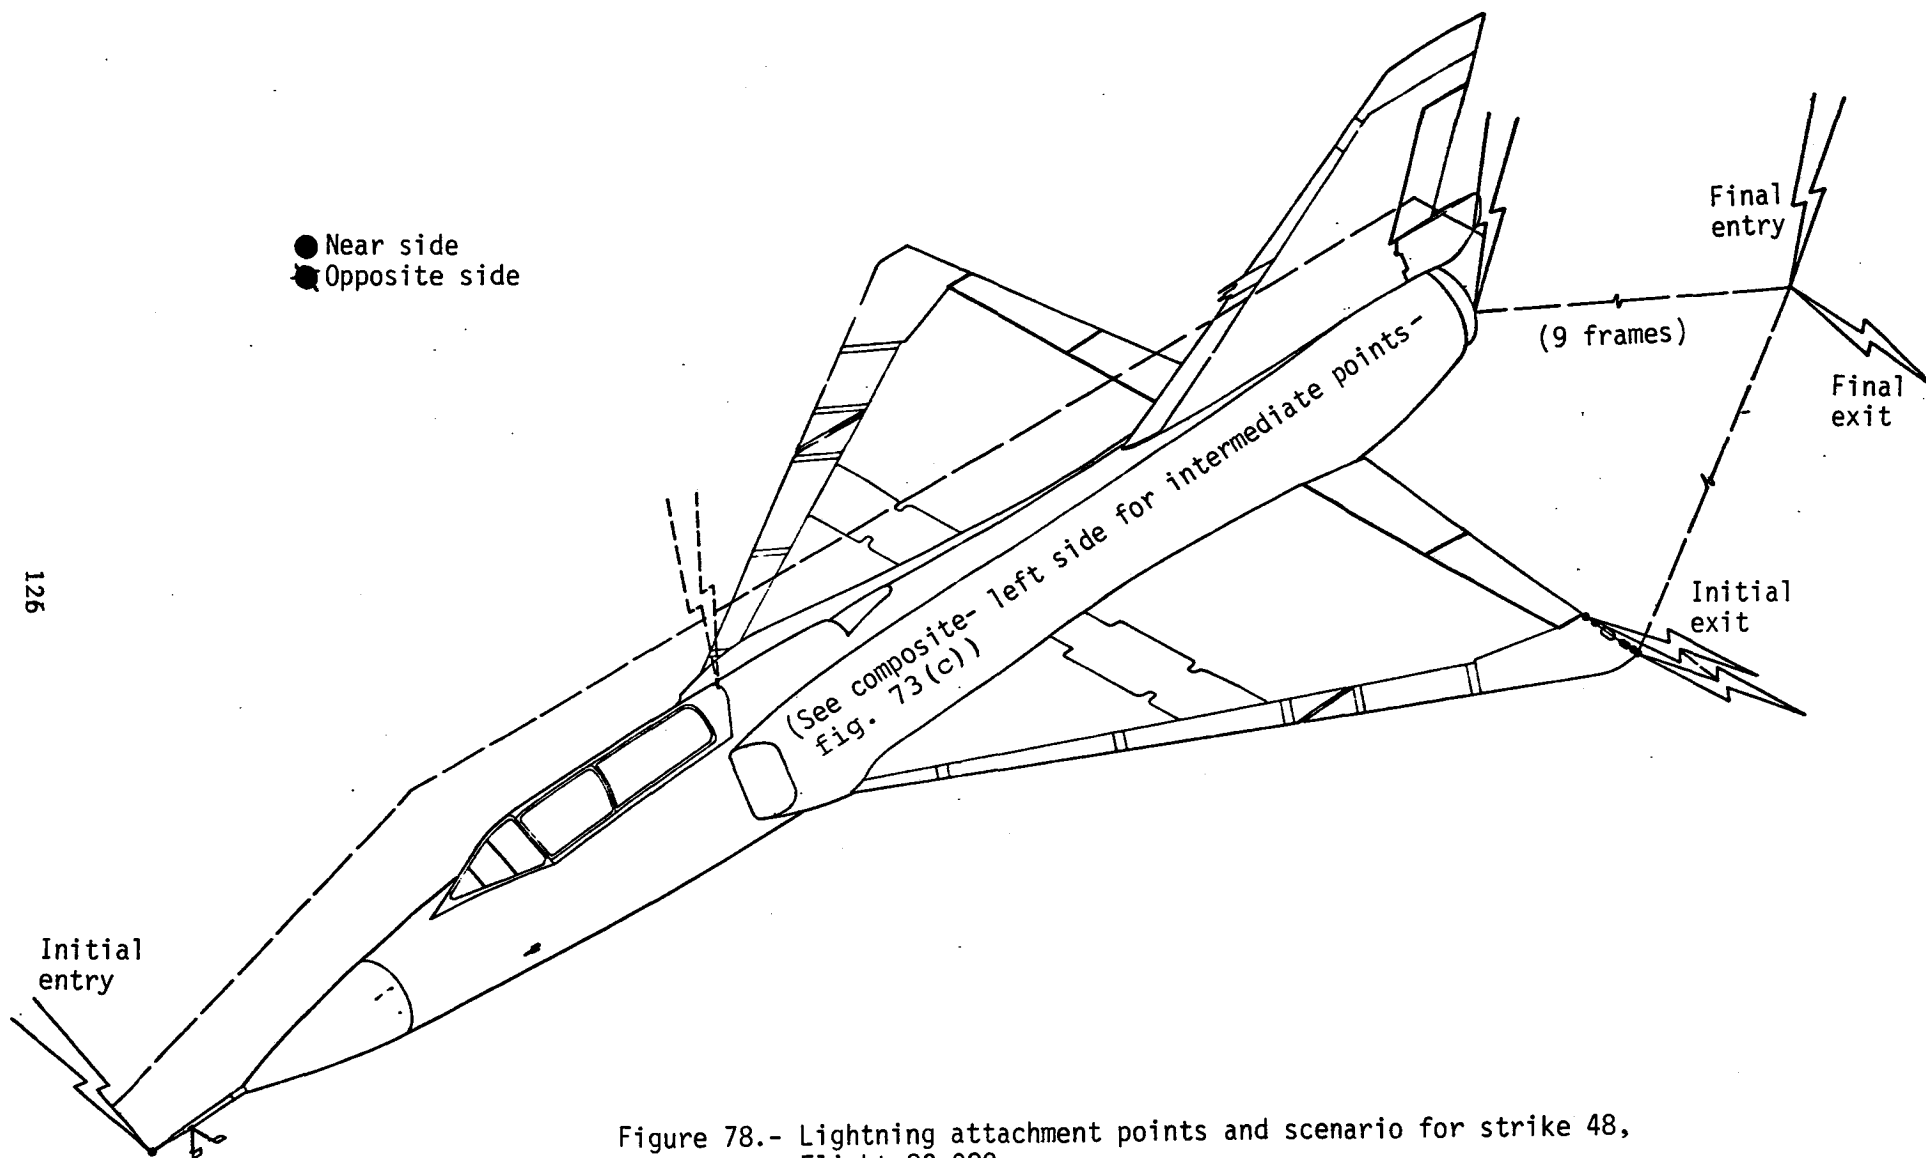
Figure 78.- Lightning attachment points and scenario for strike 48,
Flight 82-028.

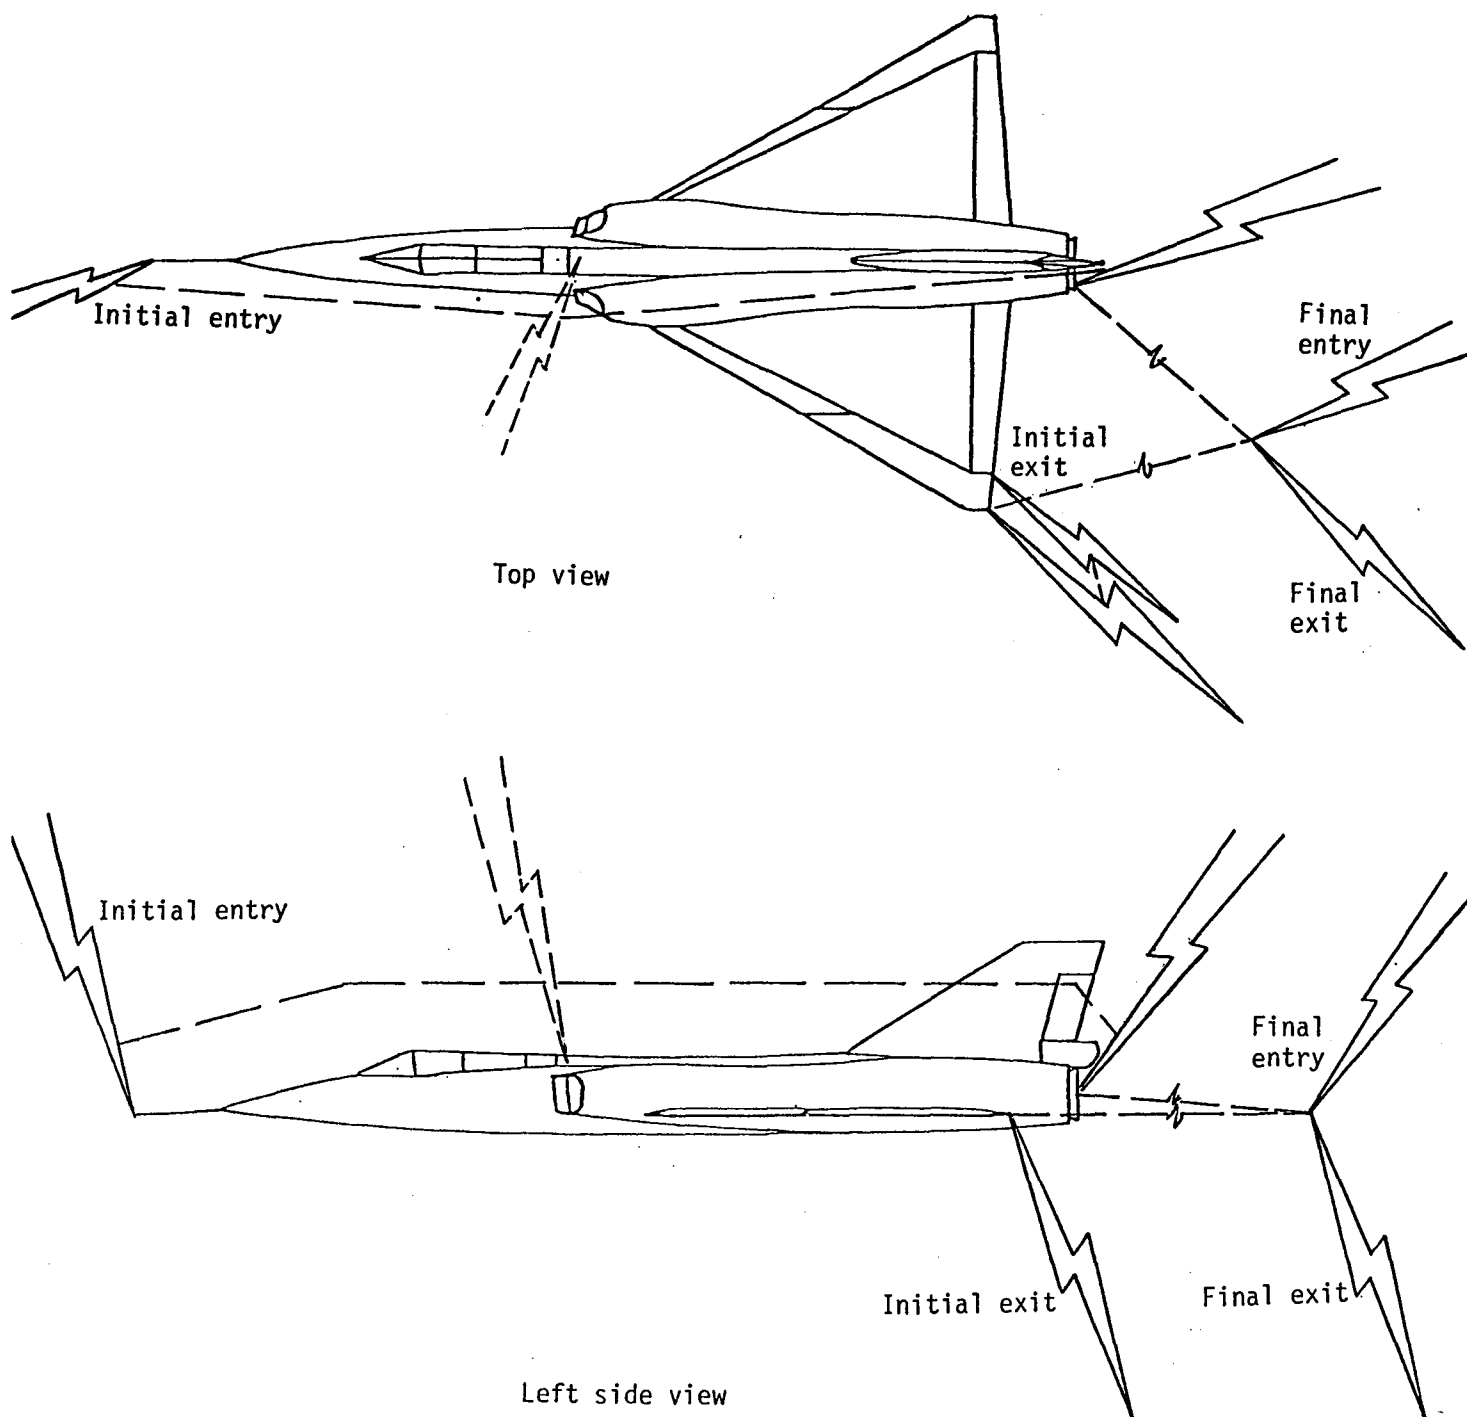
Figure 79.- Lightning attachment point scenario for strike 48, Flight 82-028.

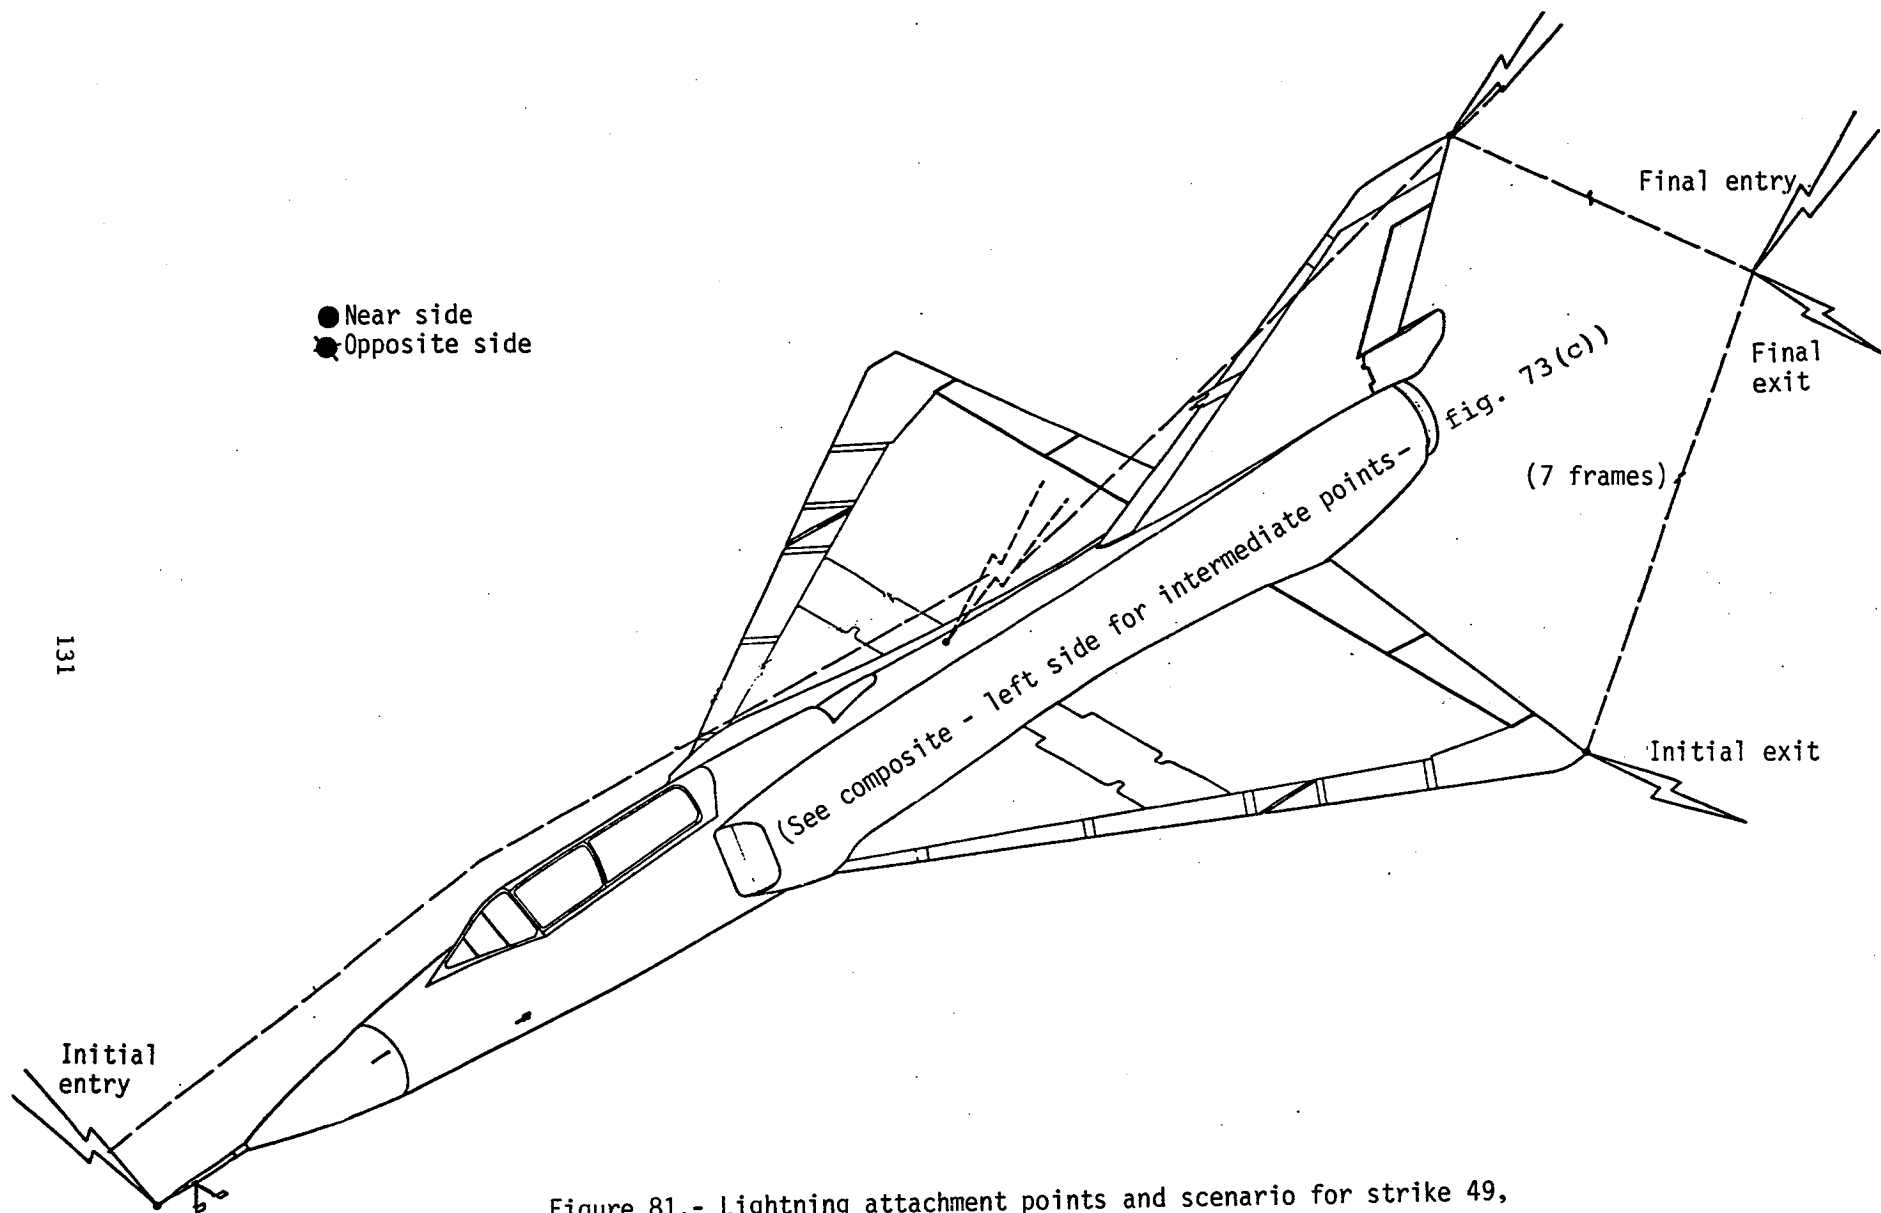
Figure 81.- Lightning attachment points and scenario for strike 49, Flight 82-028.

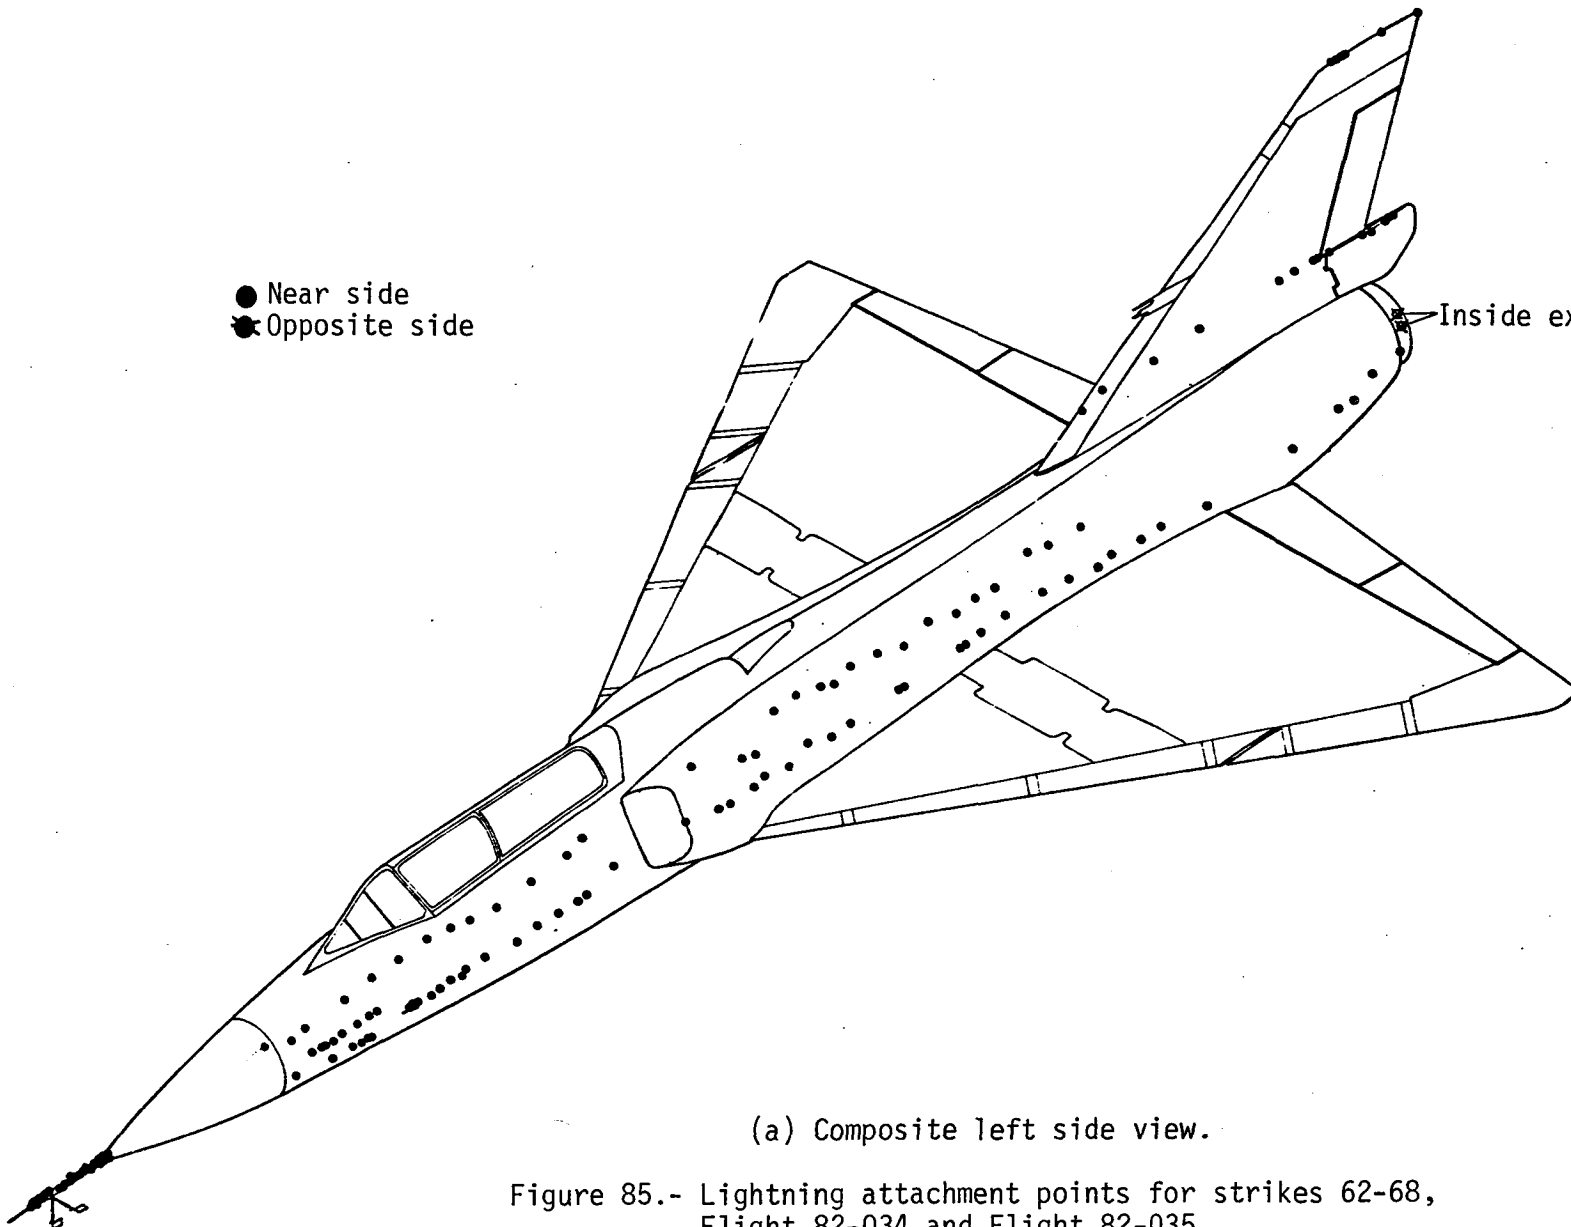
Inside exhaust nozzle

Figure 85.- Lightning attachment points for strikes 62-68,
Flight 82-034 and Flight 82-035.

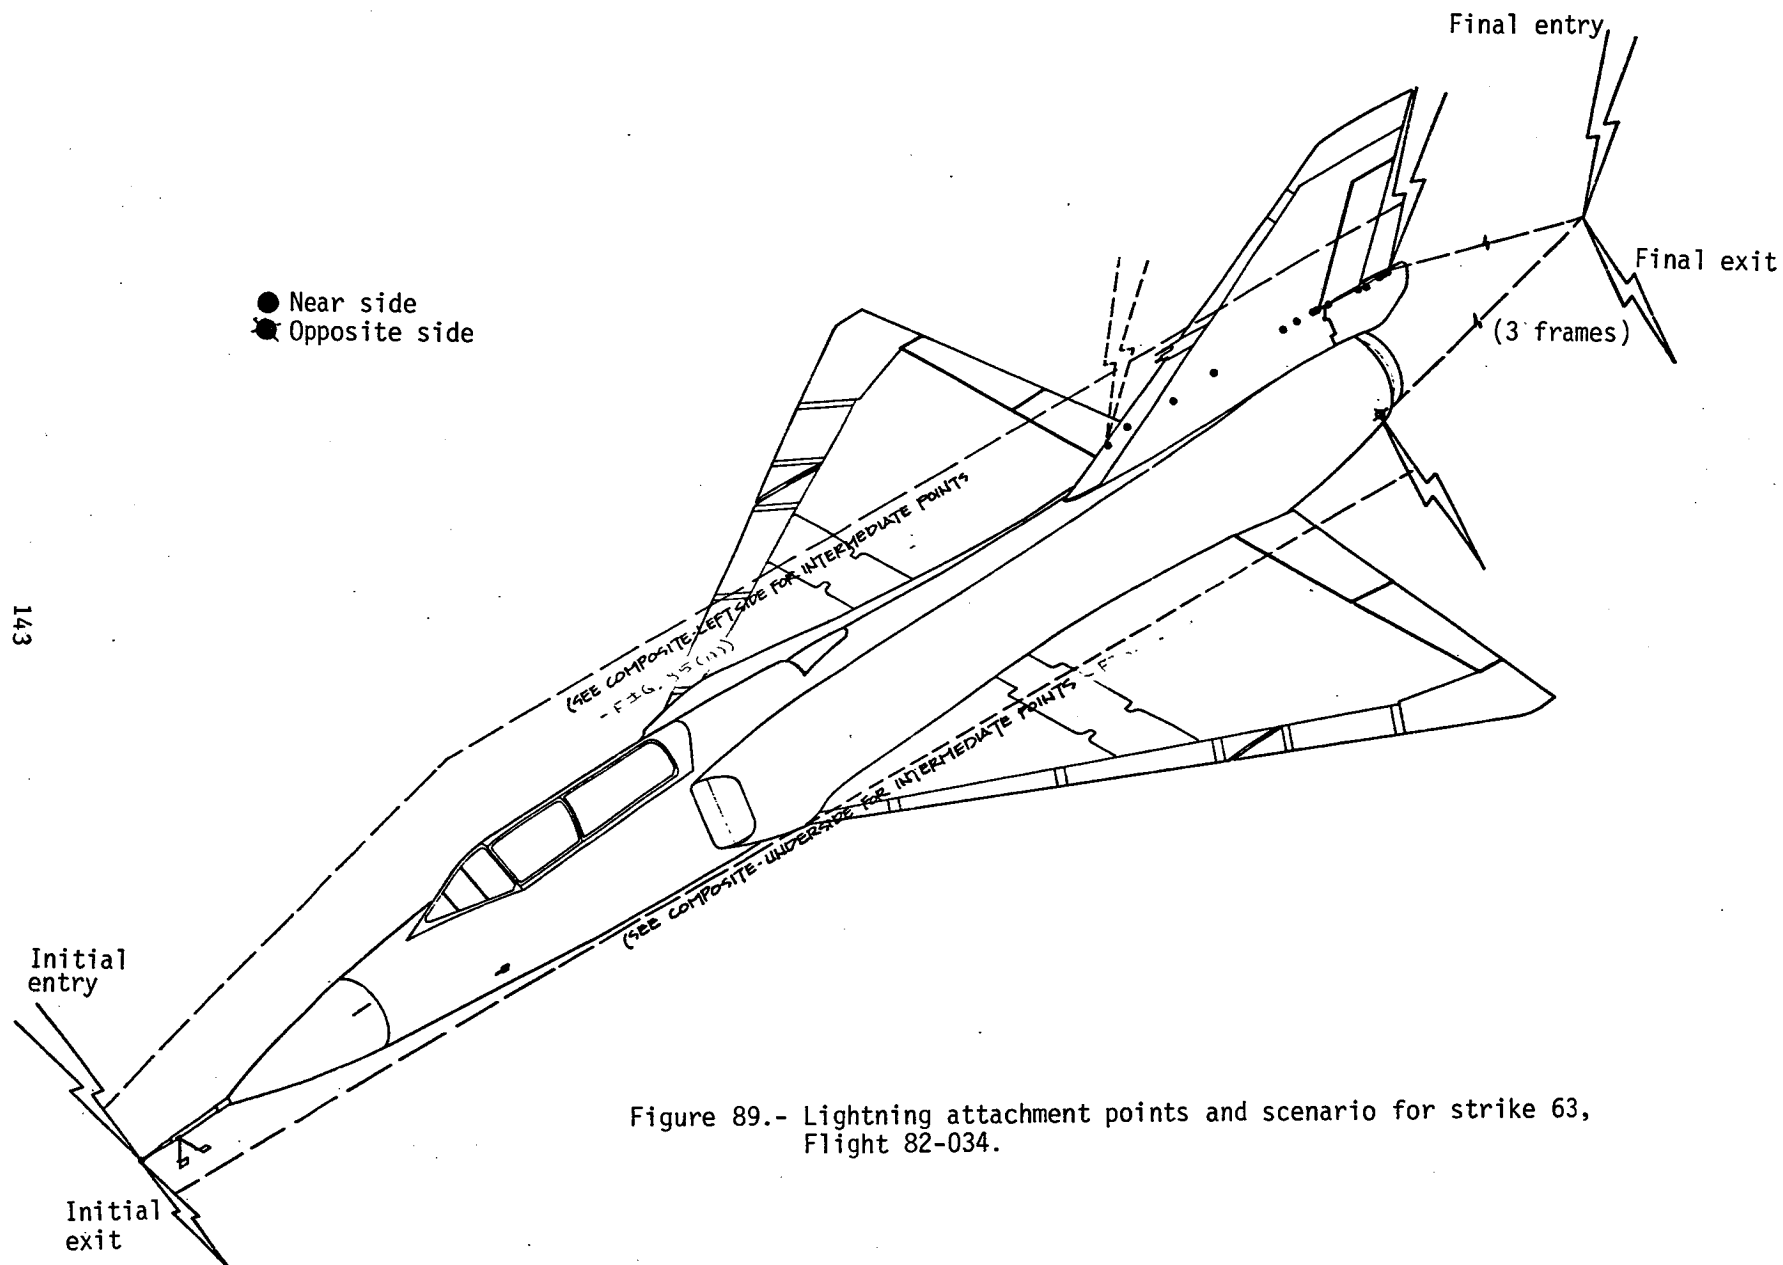
Figure 89.- Lightning attachment points and scenario for strike 63, Flight 82-034.

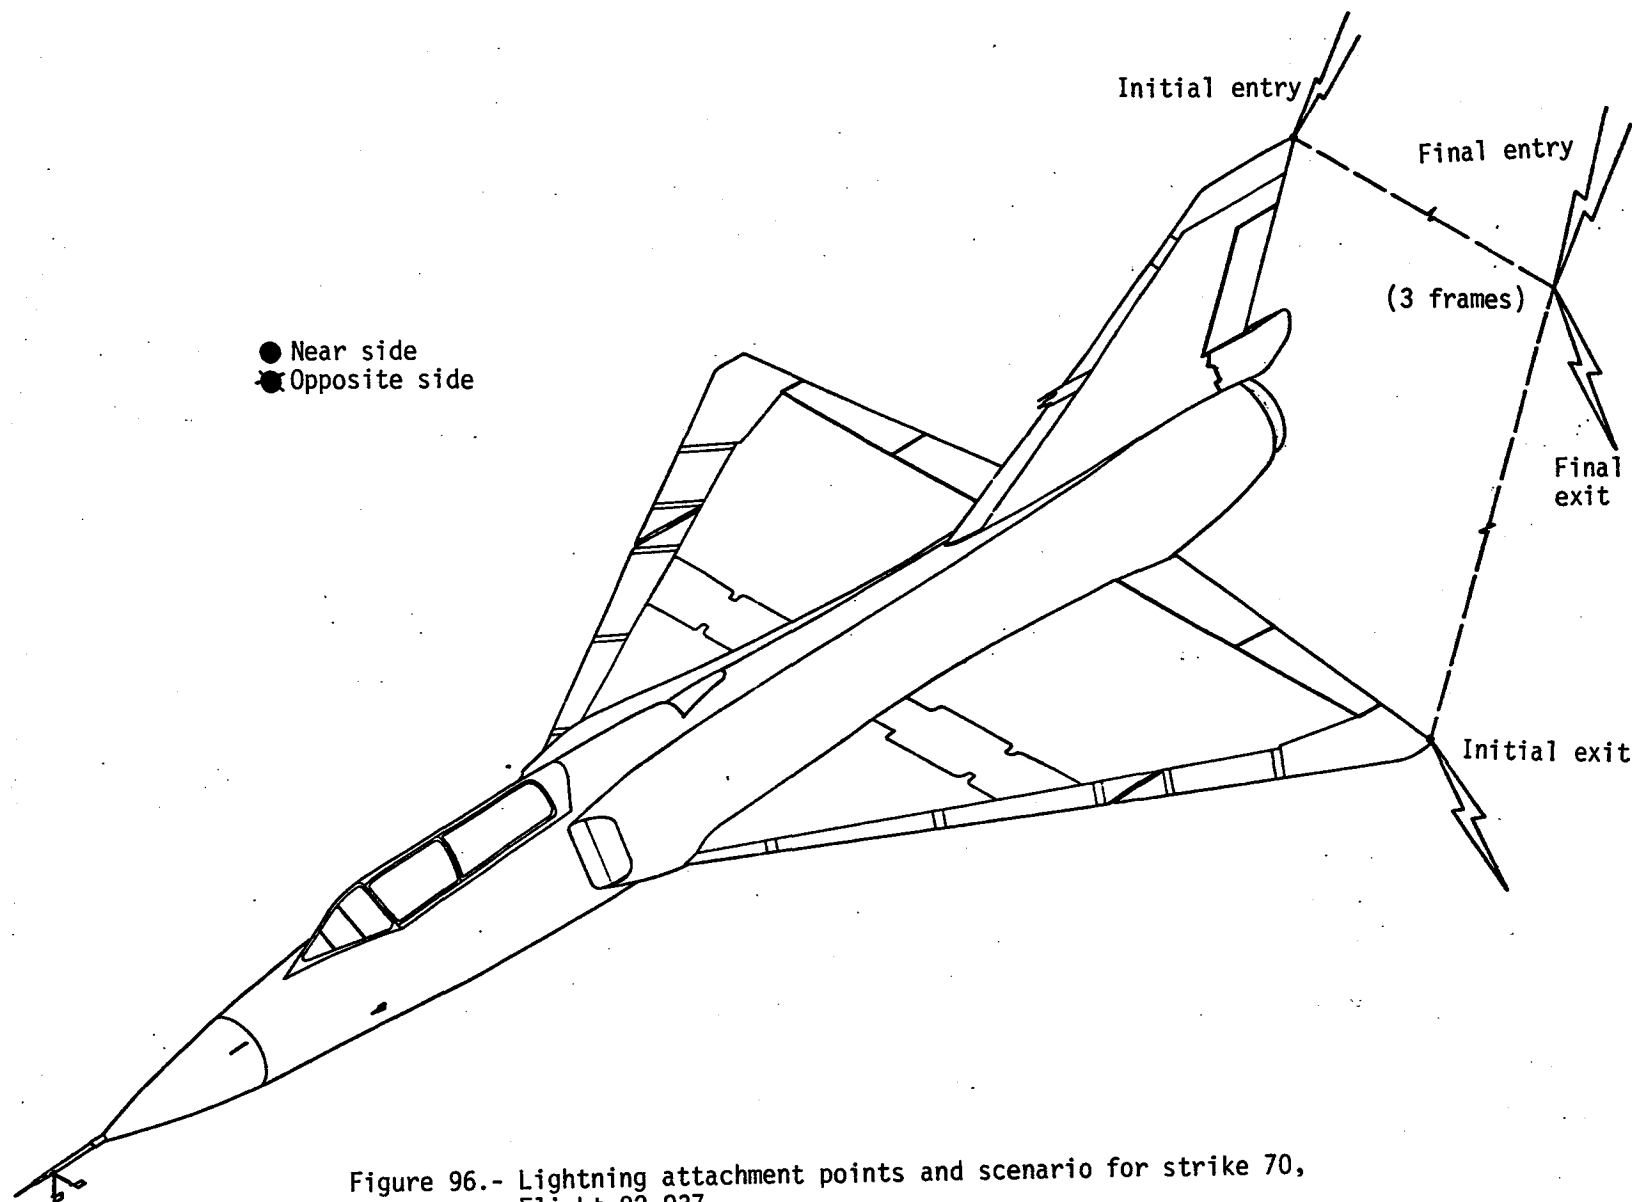
Figure 96.- Lightning attachment points and scenario for strike 70, Flight 82-037.

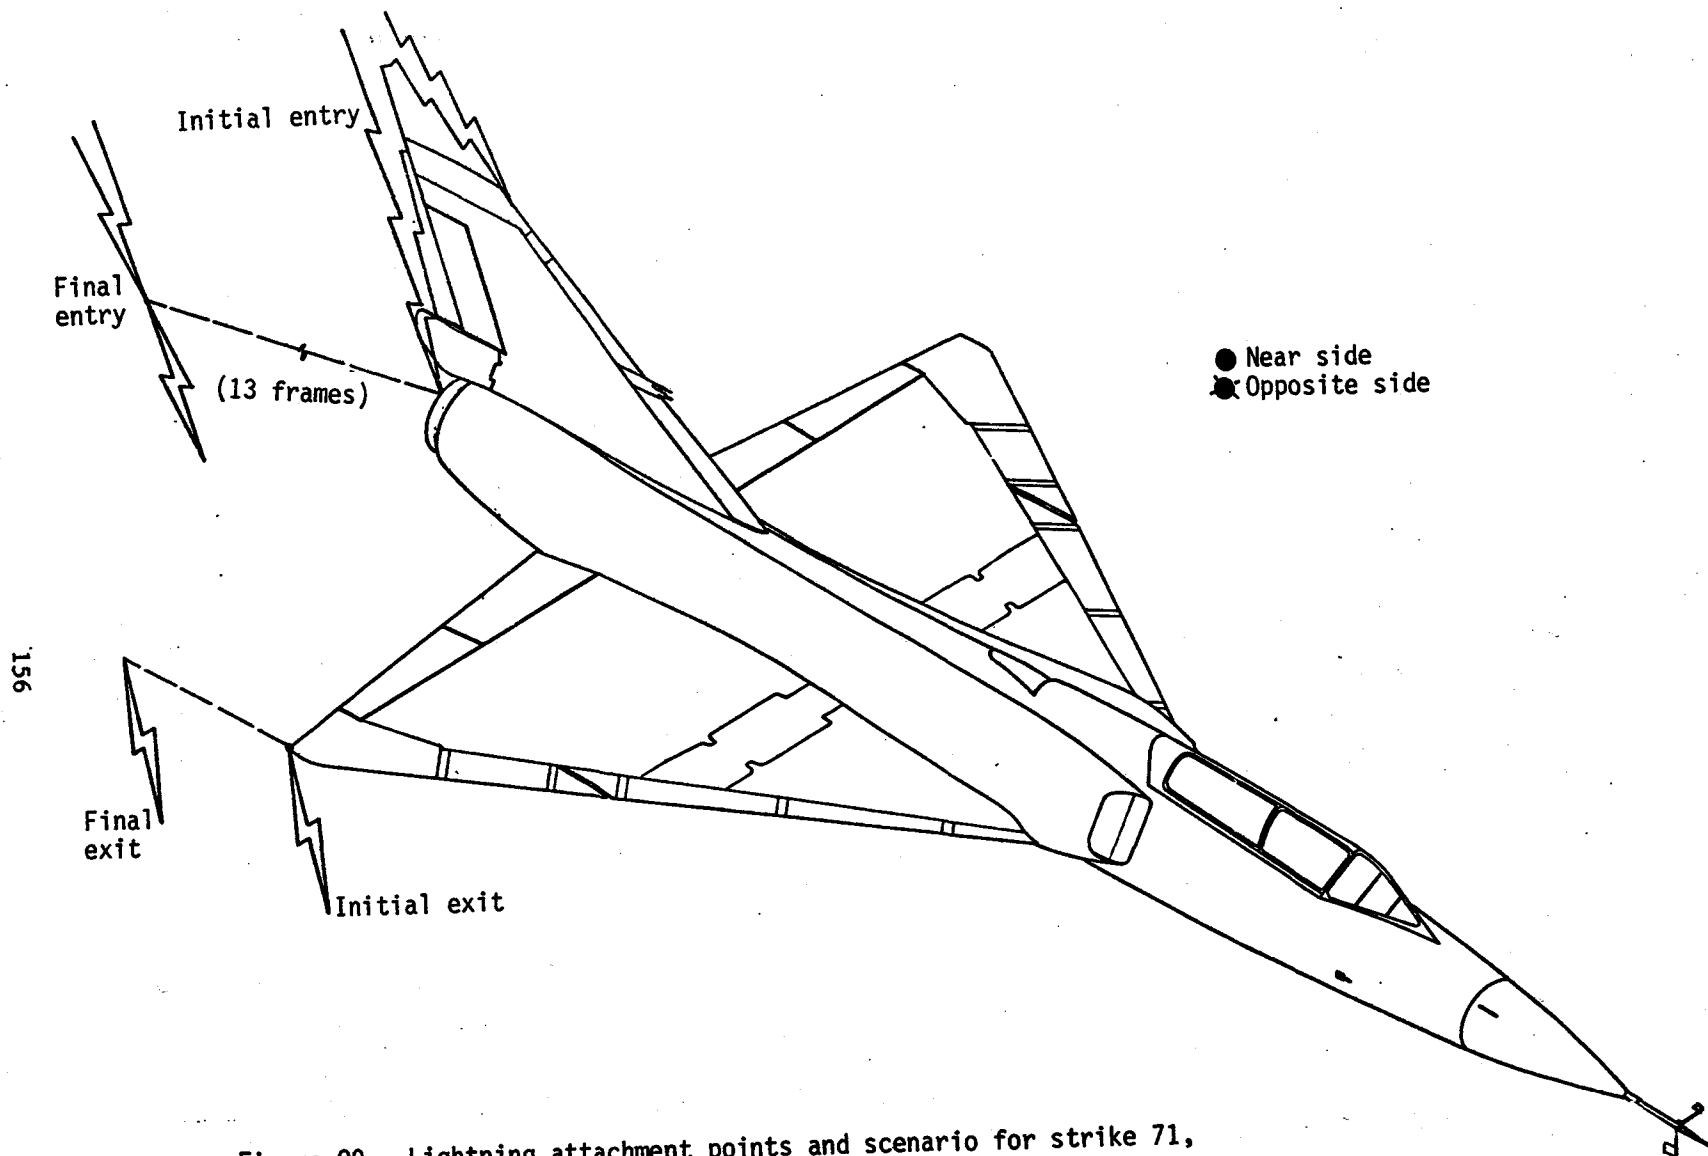
Figure 99.- Lightning attachment points and scenario for strike 71, Flight 82-038.

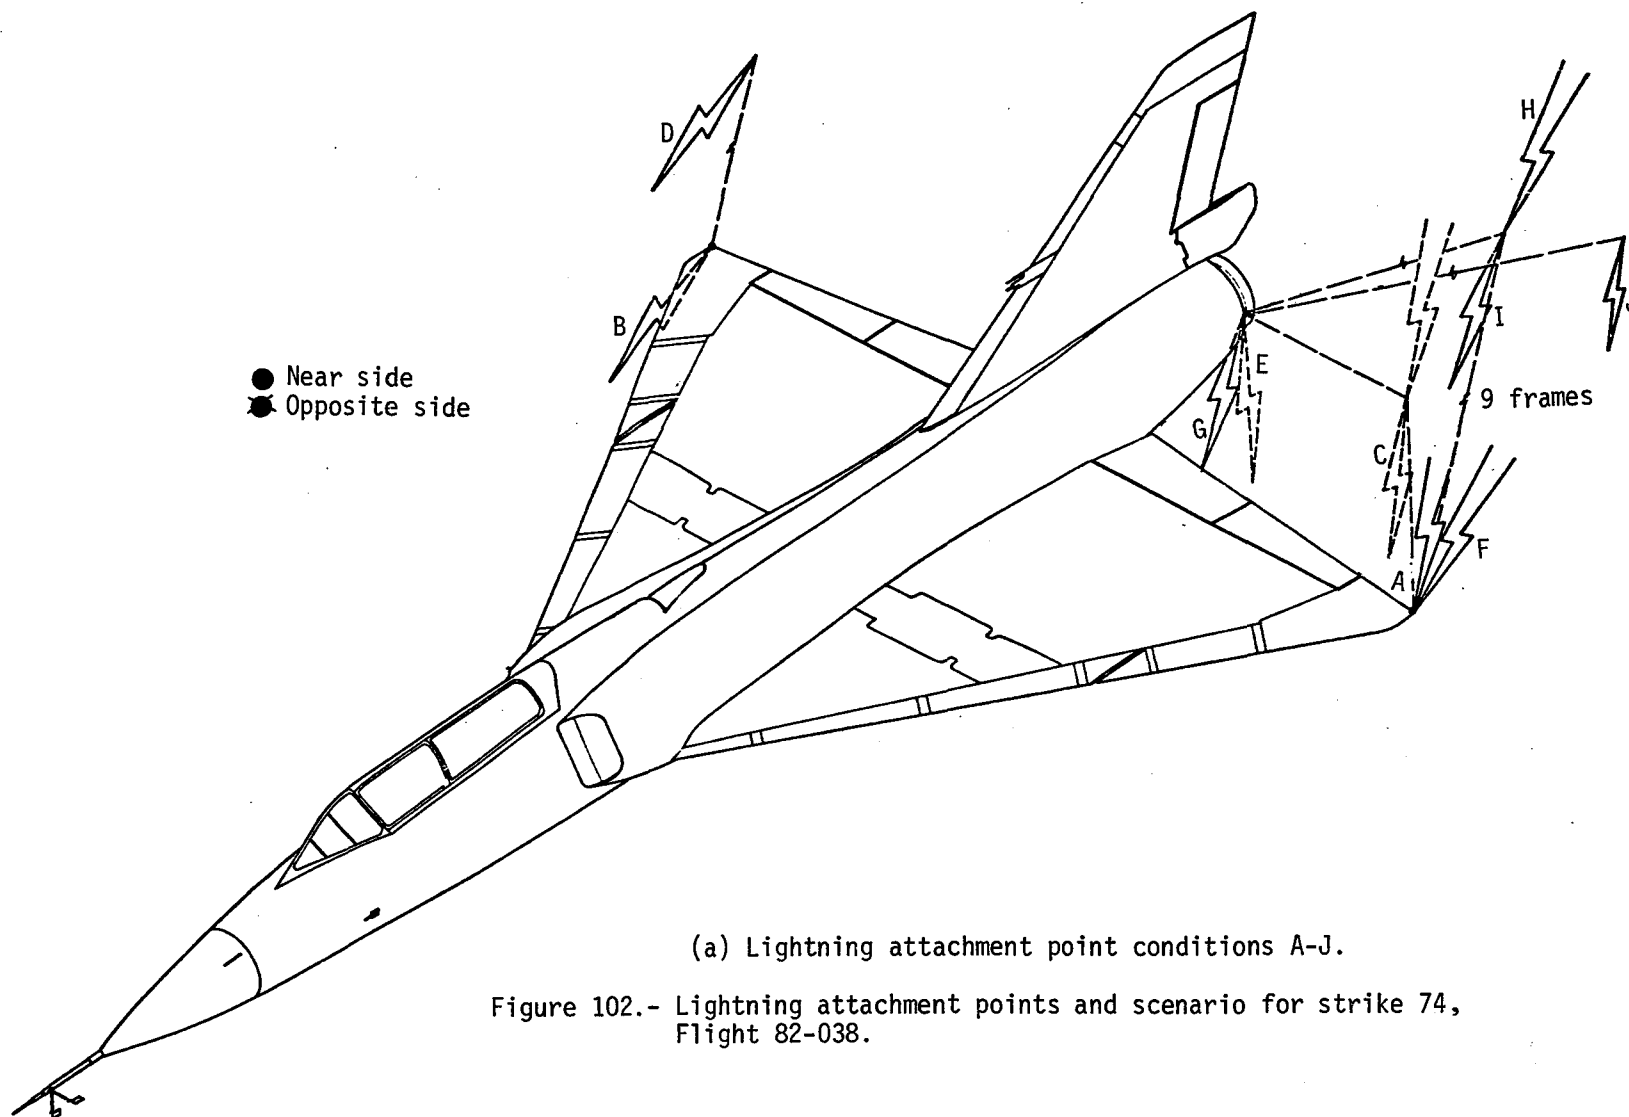
(a) Lightning attachment point conditions A-J.

Figure 102.- Lightning attachment points and scenario for strike 74, Flight 82-038.

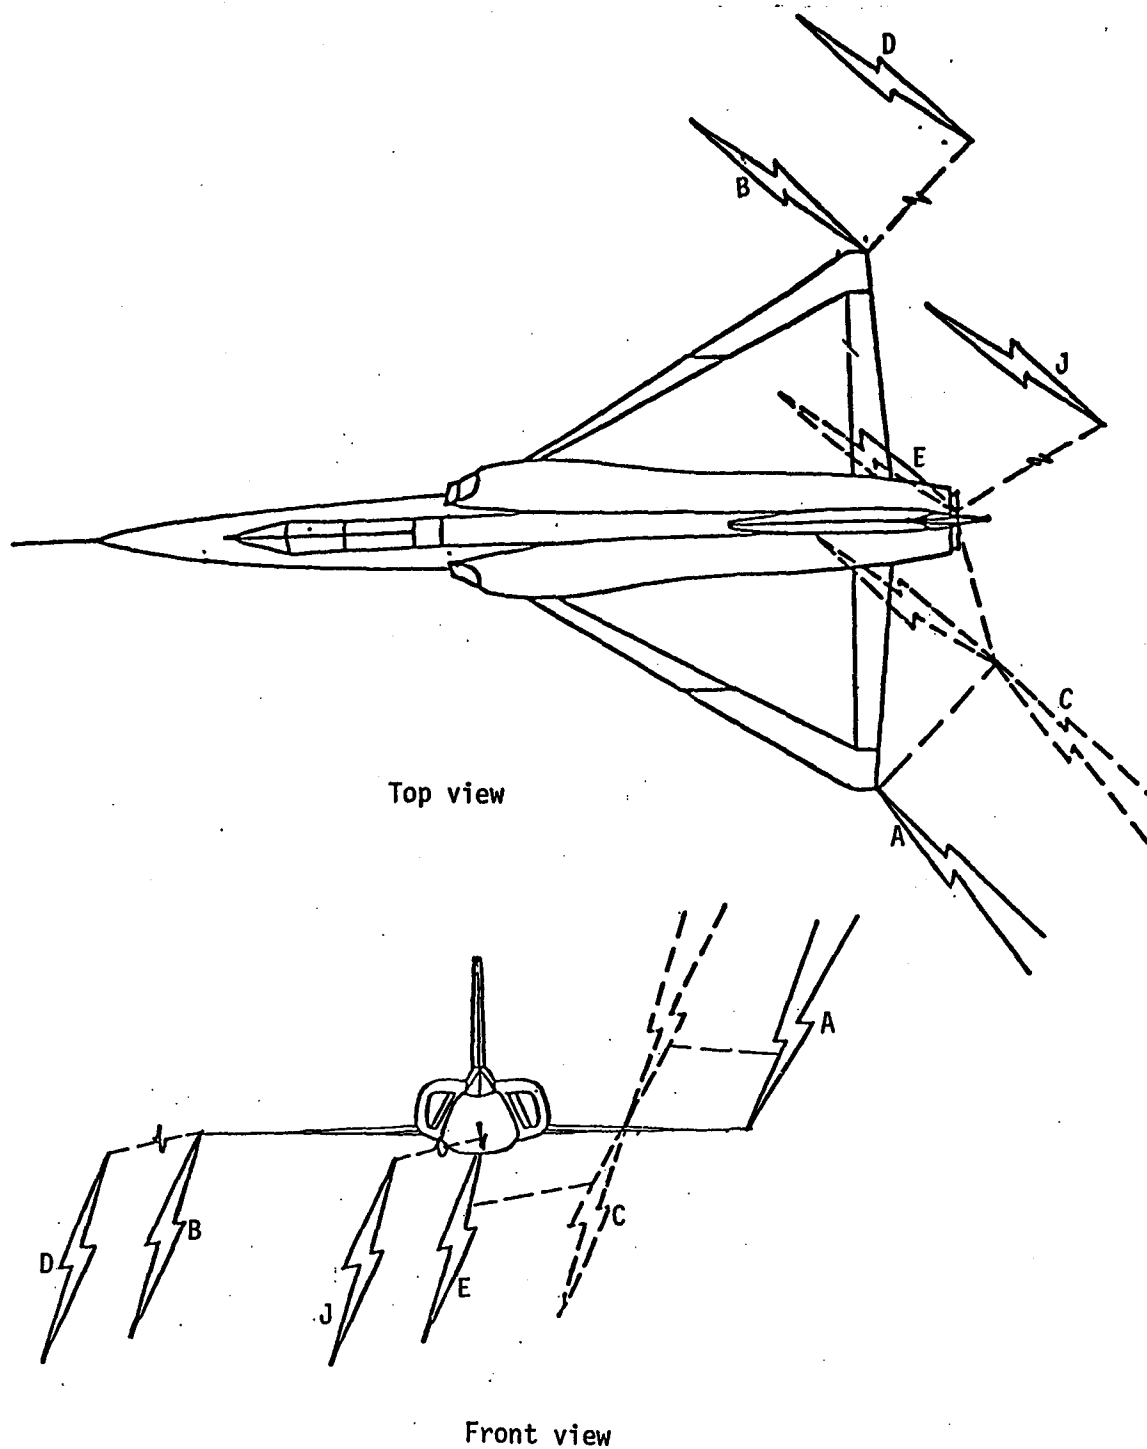
(a) Lightning attachment conditions A, B, C, D, E, and J.

Figure 103.- Lightning attachment point scenario for strike 74, Flight 82-038.

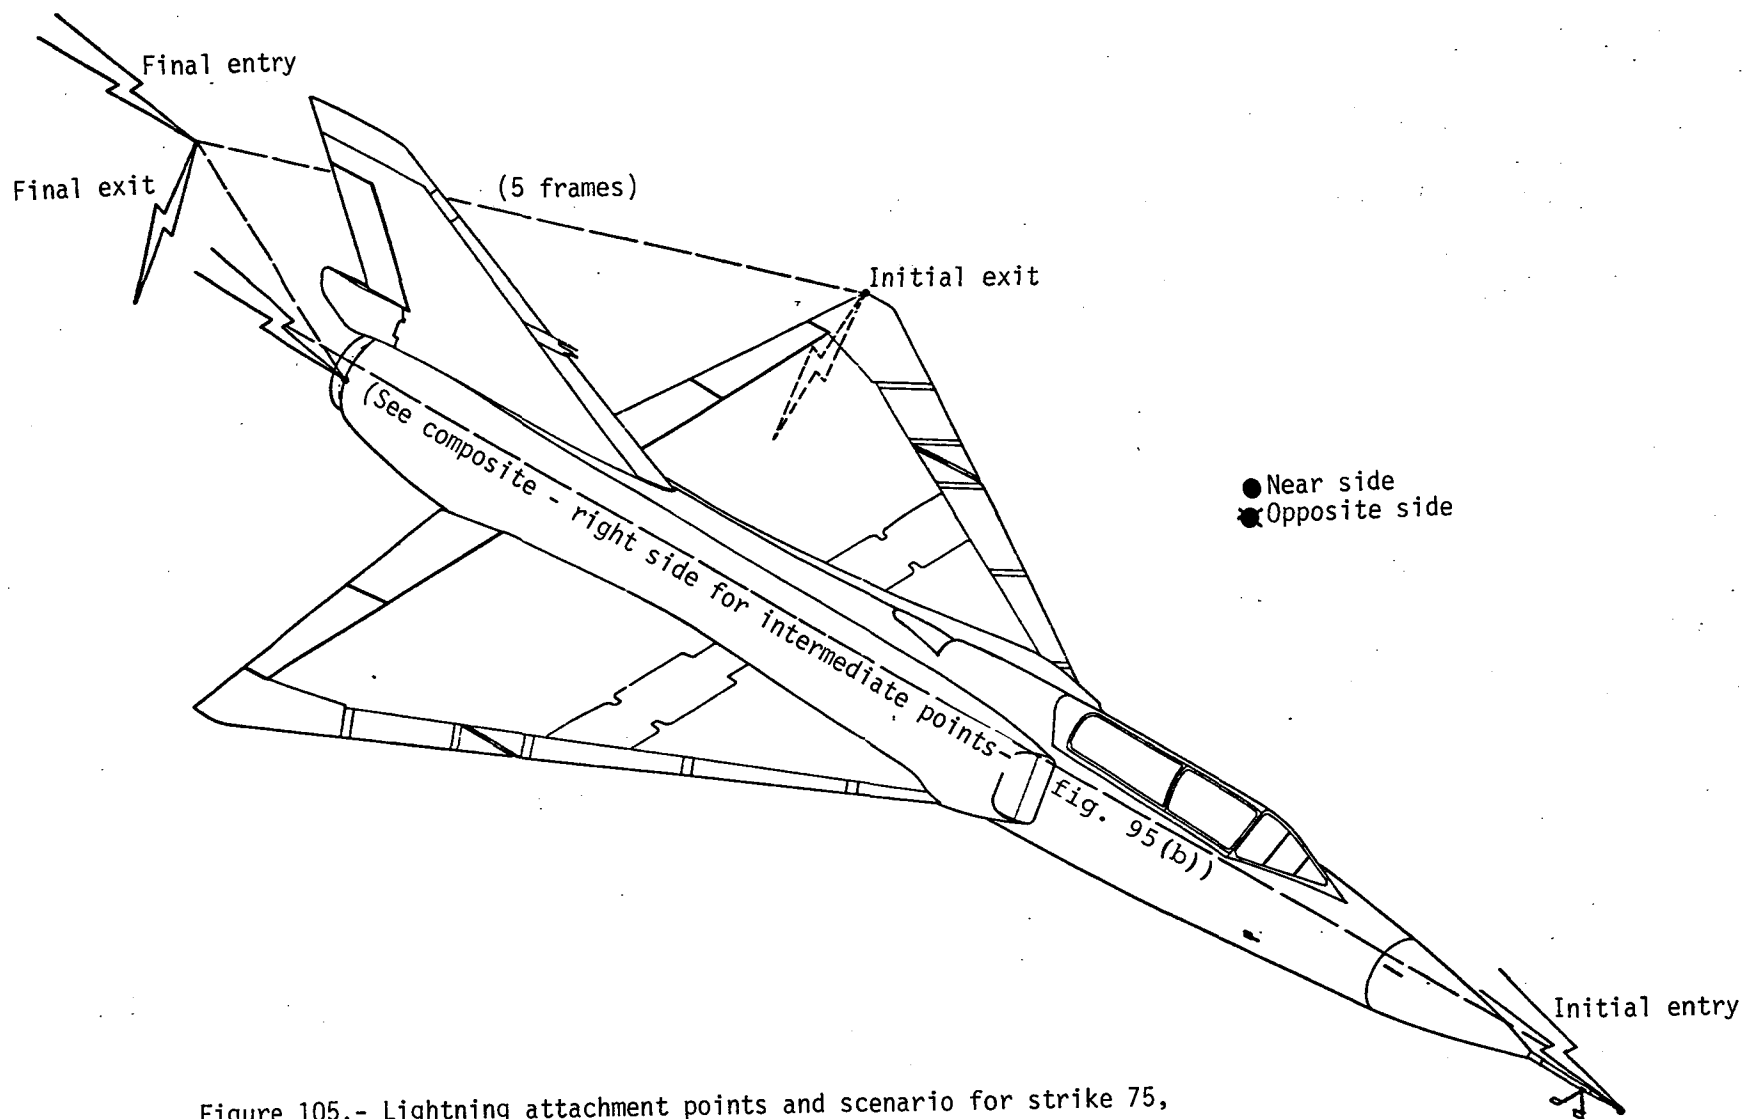
Figure 105.- Lightning attachment points and scenario for strike 75, Flight 82-038.

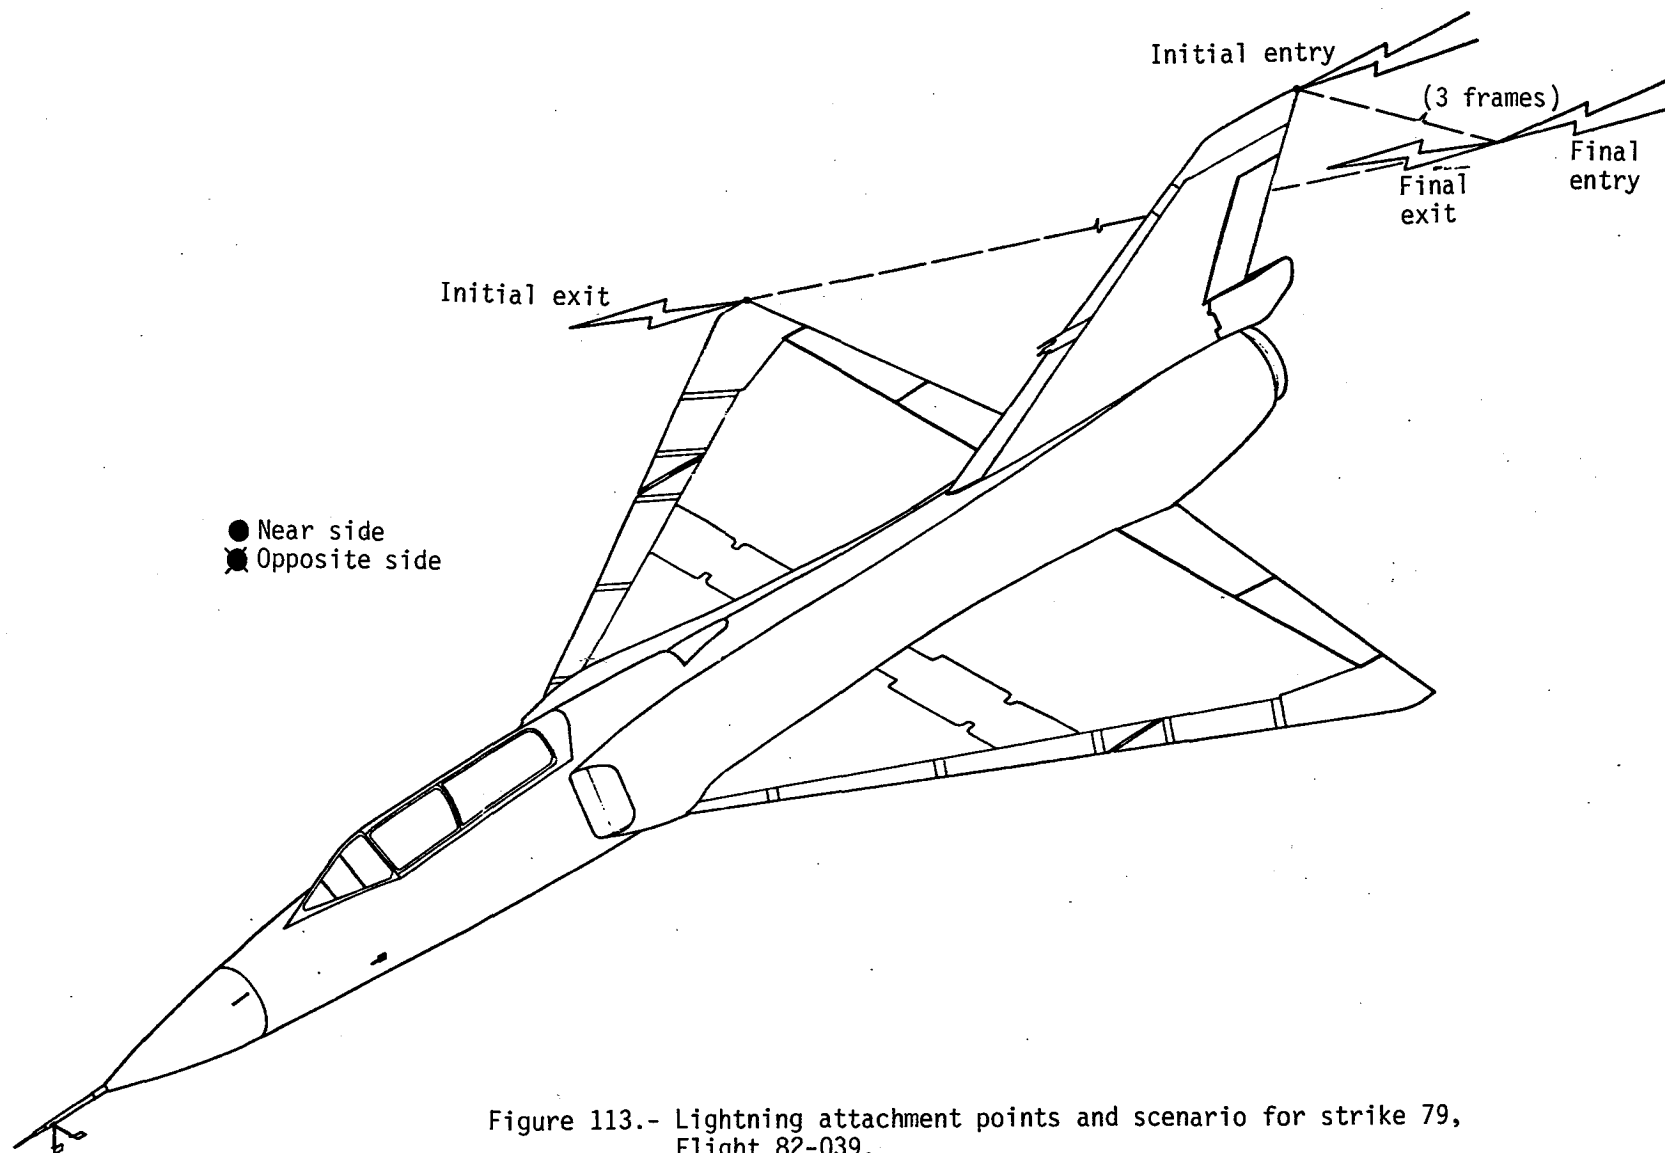
Figure 113.- Lightning attachment points and scenario for strike 79, Flight 82-039.
